Hooke Court, Hooke, Dorset

Archaeological Evaluation and Assessment of the Results

Ref: 62502.01
December 2006

Prepared on behalf of
Videotext Communications Ltd
49 Goldhawk Road
LONDON
W12 8QP

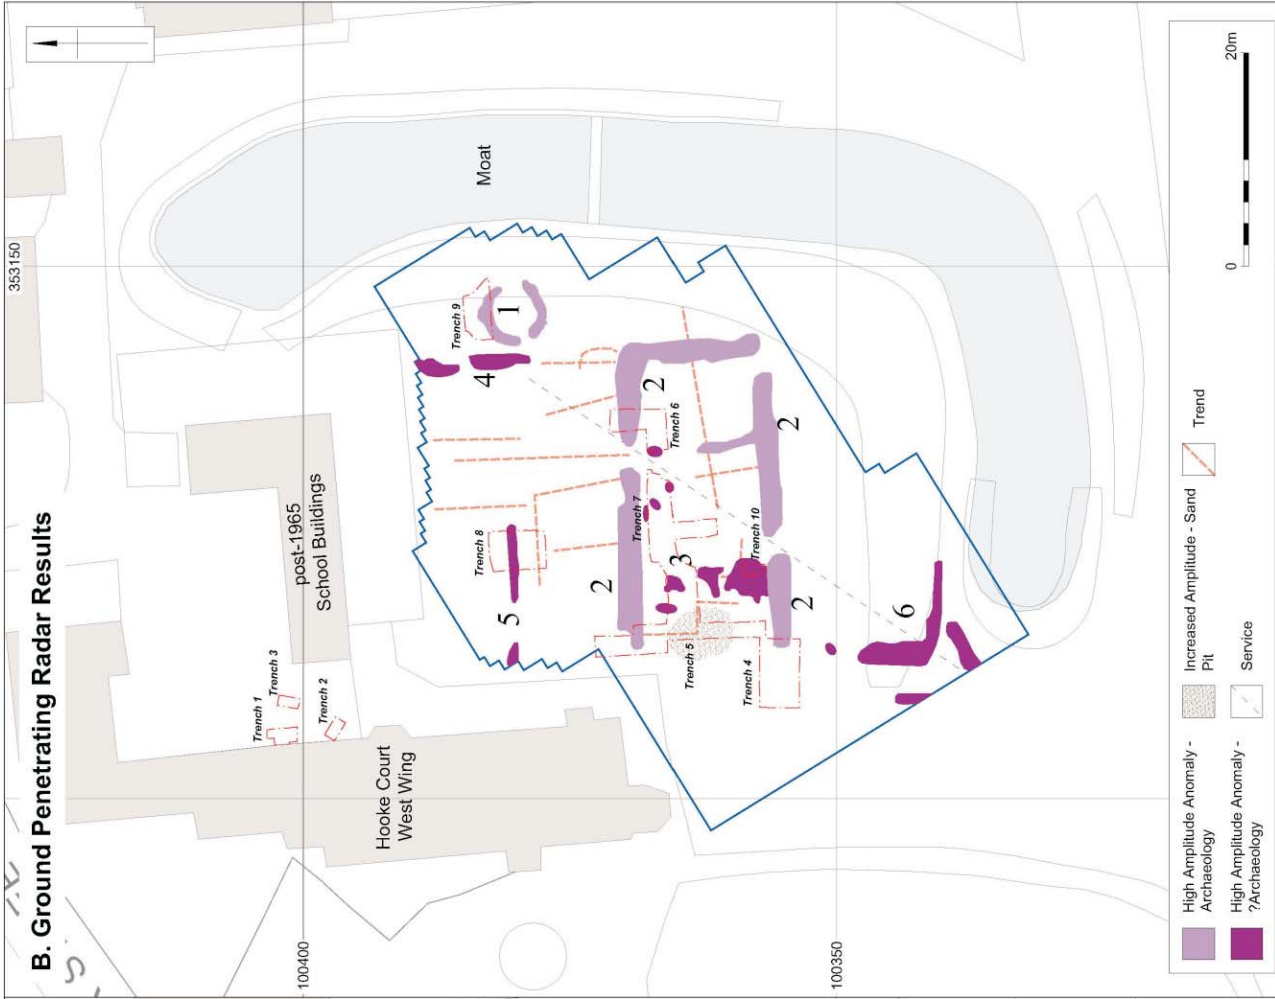
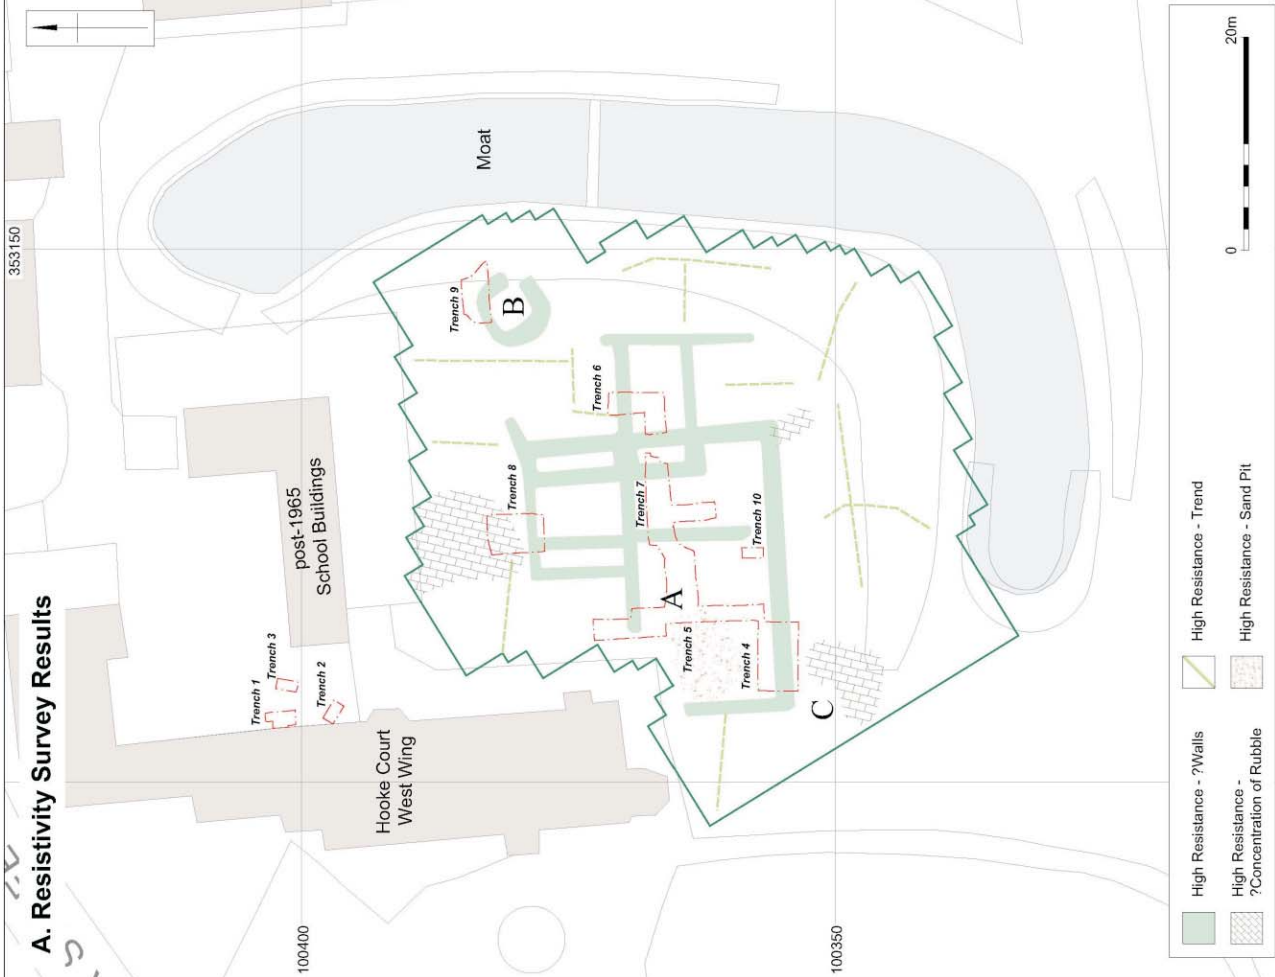
Figure 6

Interpretations of Geophysical Survey Results: A. Resistivity Survey and B. Ground Penetrating Radar

- 4.4.4 Some of the highest resistance readings were found at (A); it transpired that these coincided with the location of a former sand pit used by the school. The sand was found on excavation to still be *in situ*; the very high resistance readings are due to the fact water can drain very easily through the fine grains, unlike in 'garden' soils. It is unfortunate that the sand was overlying and effectively masking (from the resistance survey) several wall foundations associated with earlier buildings on the site.

- 4.4.10 Anomaly (1) coincides with the position of a probable dovecote as seen in the resistance data. The clear circular nature of the structure is shown from an approximate depth of 0.36m to 1.0m. The high amplitude responses, presumably indicating either foundations or walls, add weight to the interpretation of such anomalies as archaeological in origin for the rest of the site.

- 4.4.11 The high amplitude anomaly (2) forms a distinct rectilinear feature - presumably the remains of a building. Less well defined anomalies (3 to 6) form linear anomalies which may also represent foundation or wall remains but the interpretation is more speculative. Although they follow a similar orientation to anomaly (2) it is not possible to say if this is either part of the same structure or some other feature.

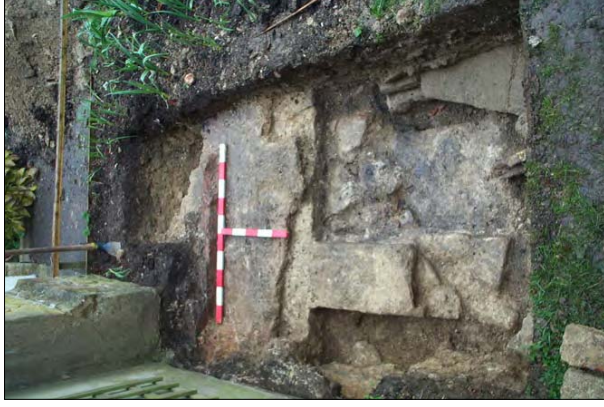
Plate 5: Trench 1 from the south (0.5 & 1m scales)

- 4.5.4 The earliest structures within Trench 1 comprised large sandstone blocks (103), (104) and (108) which potentially formed part of the foundations for the demolished North Wing. The second phase of building appears to have been north-south aligned sandstone wall (105) which butts block (103) and physically sits upon block (104). It is possible that (105) belongs to the same period of construction as (103) and (104), but this is not clear.

- 4.5.6 A number of unexcavated deposits were identified adjacent to structures (103), (104) and (108) and it is unclear whether these demolition layers of un-recyclable material pre-date or post-date the sandstone structures. The deposits (110), (111), and (112) appear derived from the cleaning of masonry and the discarding of mortar and broken stone. Burnt rubble deposit (109) may relate to the 1965 demolition.

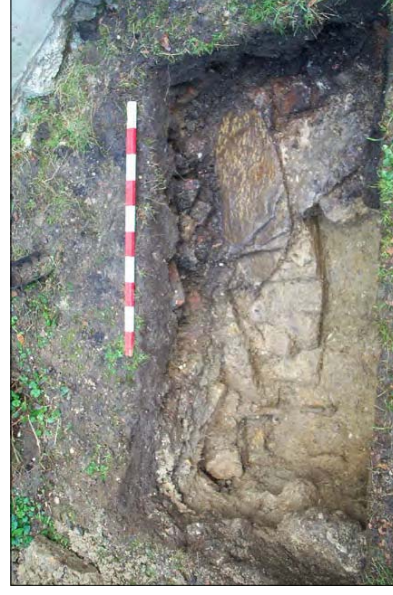
Plate 7: Trench 2 from the north (1m scale)

- 4.5.9 The earliest structure identified was (207), oolitic limestone stonework blocks which formed a slight curving structure interpreted as the foundation material of the newel staircase. This was butted by a roughly north-south aligned structure (206) from a second phase of the building. This may be contemporaneous with (207) but it is clearly stratigraphically later, and of unknown function.

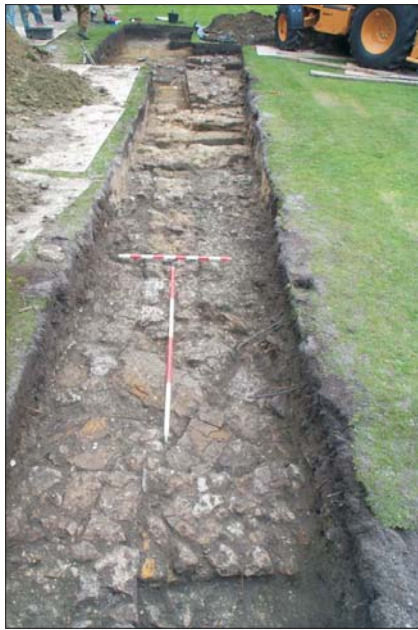
Plate 9: Trench 5 area from the south (Scales = 1m & 2m)

- 4.5.23 Phase 2 comprises the first identifiable phase (of four) of building construction on the site. The nature of the structure identified is unclear as it was not revealed in its entirety, but it appears to form part of an east-west aligned building, 2.6m in width. The structure was formed by walls (508) and (517), and possible corner tower or buttress foundation (520). Each wall was constructed from large roughly shaped sandstone blocks and bonded with sand mortar.

- 4.5.24 Wall (508) was built within a foundation trench that cut through Phase 1 pits (515) and (548). The trench was backfilled with (509), and a sondage excavated through the construction cut showed that the wall had a single stepped foundation. Wall (517) was constructed within foundation trench (516), filled with backfill deposit (510). The construction cut (553) for substantial corner structure (520) cut through Phase 1 deposit (527).

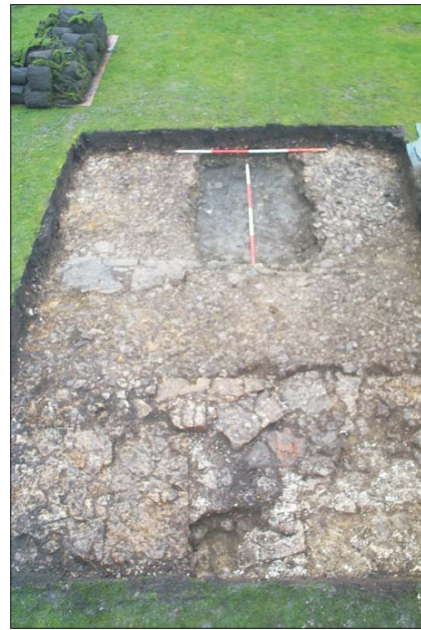
Plate 10: Trench 8 from the south (Scales = 2m & 2m)

- 4.5.50 Located to the west of the north-western corner of the building was a possible porch type structure comprising a large limestone flagged floor and a possible door sill foundation. The flagged floor (810) was only partially exposed and consisted of two large limestone flags, with the door sill (811) to the north. It would appear, therefore, that the main entrance into the building was from the north, which is potentially where the gate house to the complex was situated. Therefore one would enter through the gate house and immediately face the entrance to a large building, potentially the Great Hall of the manor complex.

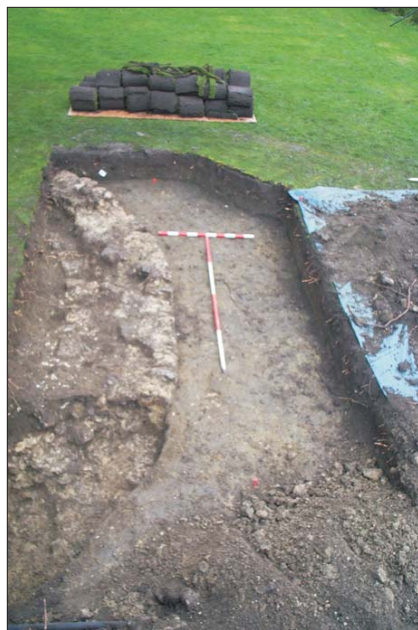
Plate 11: Trench 9 from the east (Scales = 1m & 2m)

- 4.5.28 The northern half of a circular building, *c.*4.8 m in diameter, was revealed below the topsoil (901) and sub soil (902/903) (**Figure 9, Plate 11**). Wall (904) was constructed of roughly hewn sandstone blocks within construction cut (905) and was interpreted as the foundation blocks of the walls of a dovecote. The wall had clearly been truncated during the landscaping of the moat lawn and the eastern portion had been completely removed.
- 4.5.29 No dating as recovered from the construction cut of the dovecote structure though sherds of 11th -13th century pottery were recovered from the subsoil and topsoil. The structure has been tentatively dated to the later 14th century on documentary evidence alone, as the Calendar Roll Inquisitions of 1361 record a dovecote on the Site.
