Hunstrete Grand Mansion, Somerset

Archaeological Evaluation and Assessment of Results

Report reference: 65310.01

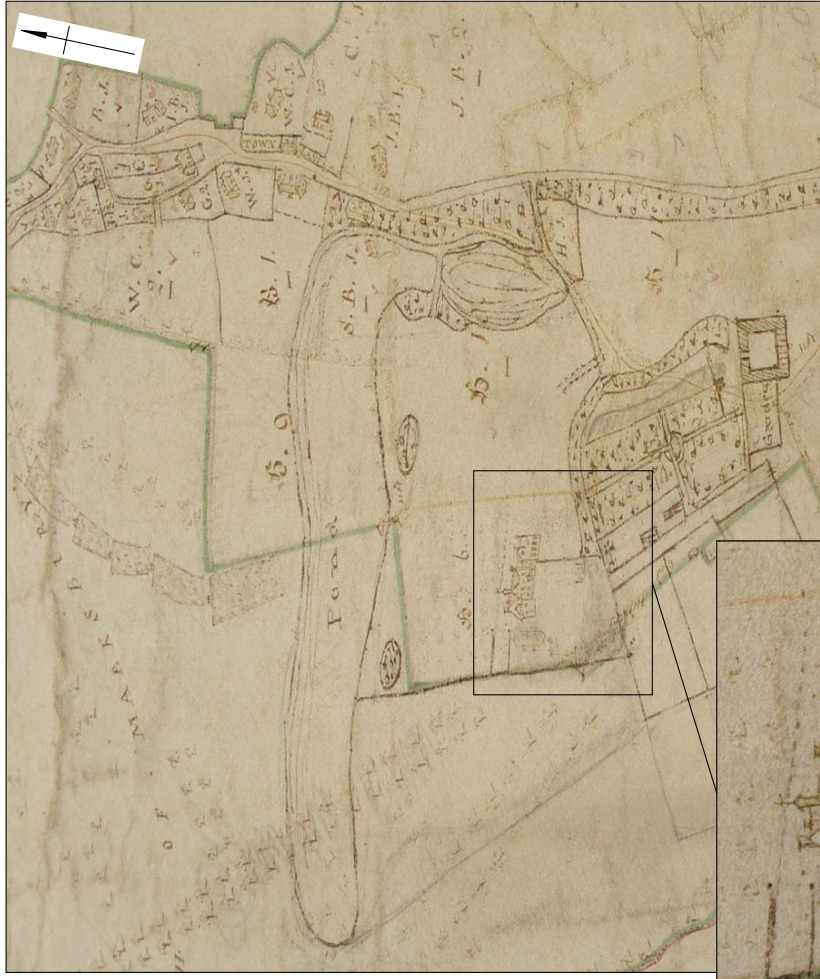
(a) Details of Survey and map of the manors of Houndstreet and Marksbury 1759 (courtesy of Somerset Record Office ref. DD/PO/67)

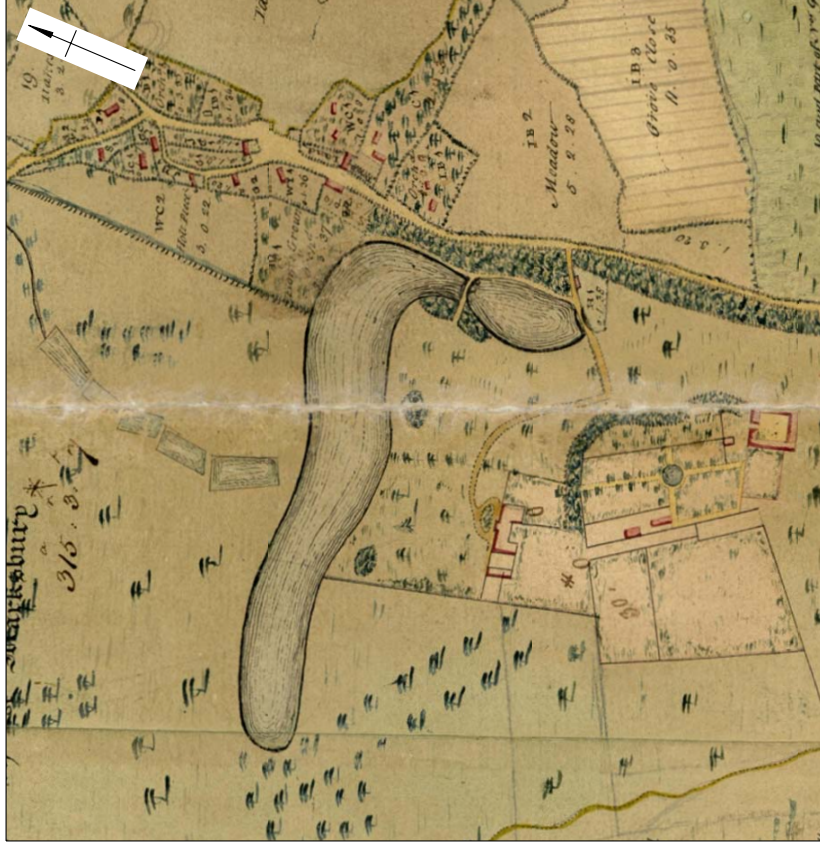
(b) Detail of Survey, map, and valuation of the Houndstreet Estate, etc. 1806, 1807 (courtesy of Somerset Record Office ref. DD/PO/73)

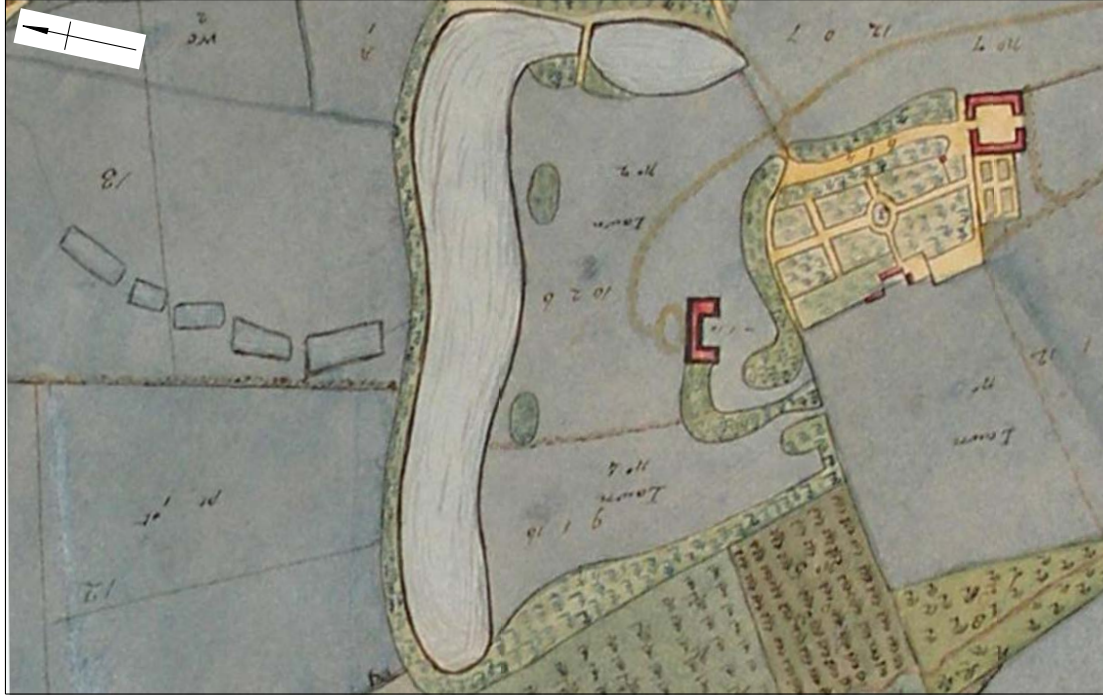
(a) Detail of 'Survey of the Houndstreet Estate 1820' (courtesy of Somerset Record Office ref. DD/PO/80)

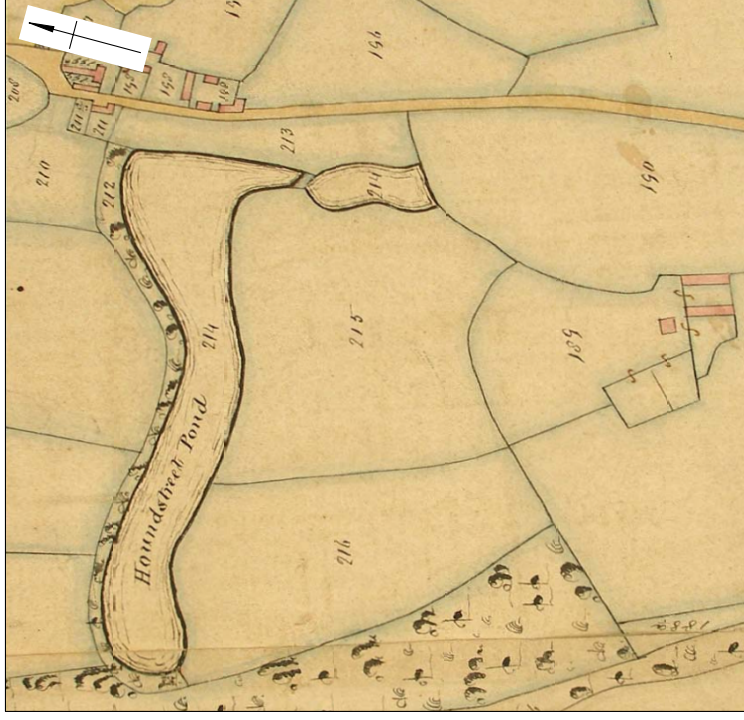
(b) Detail of 'Survey and map of the Houndstreet Estate 1846' (courtesy of Somerset Record Office ref. DD/PO/86)

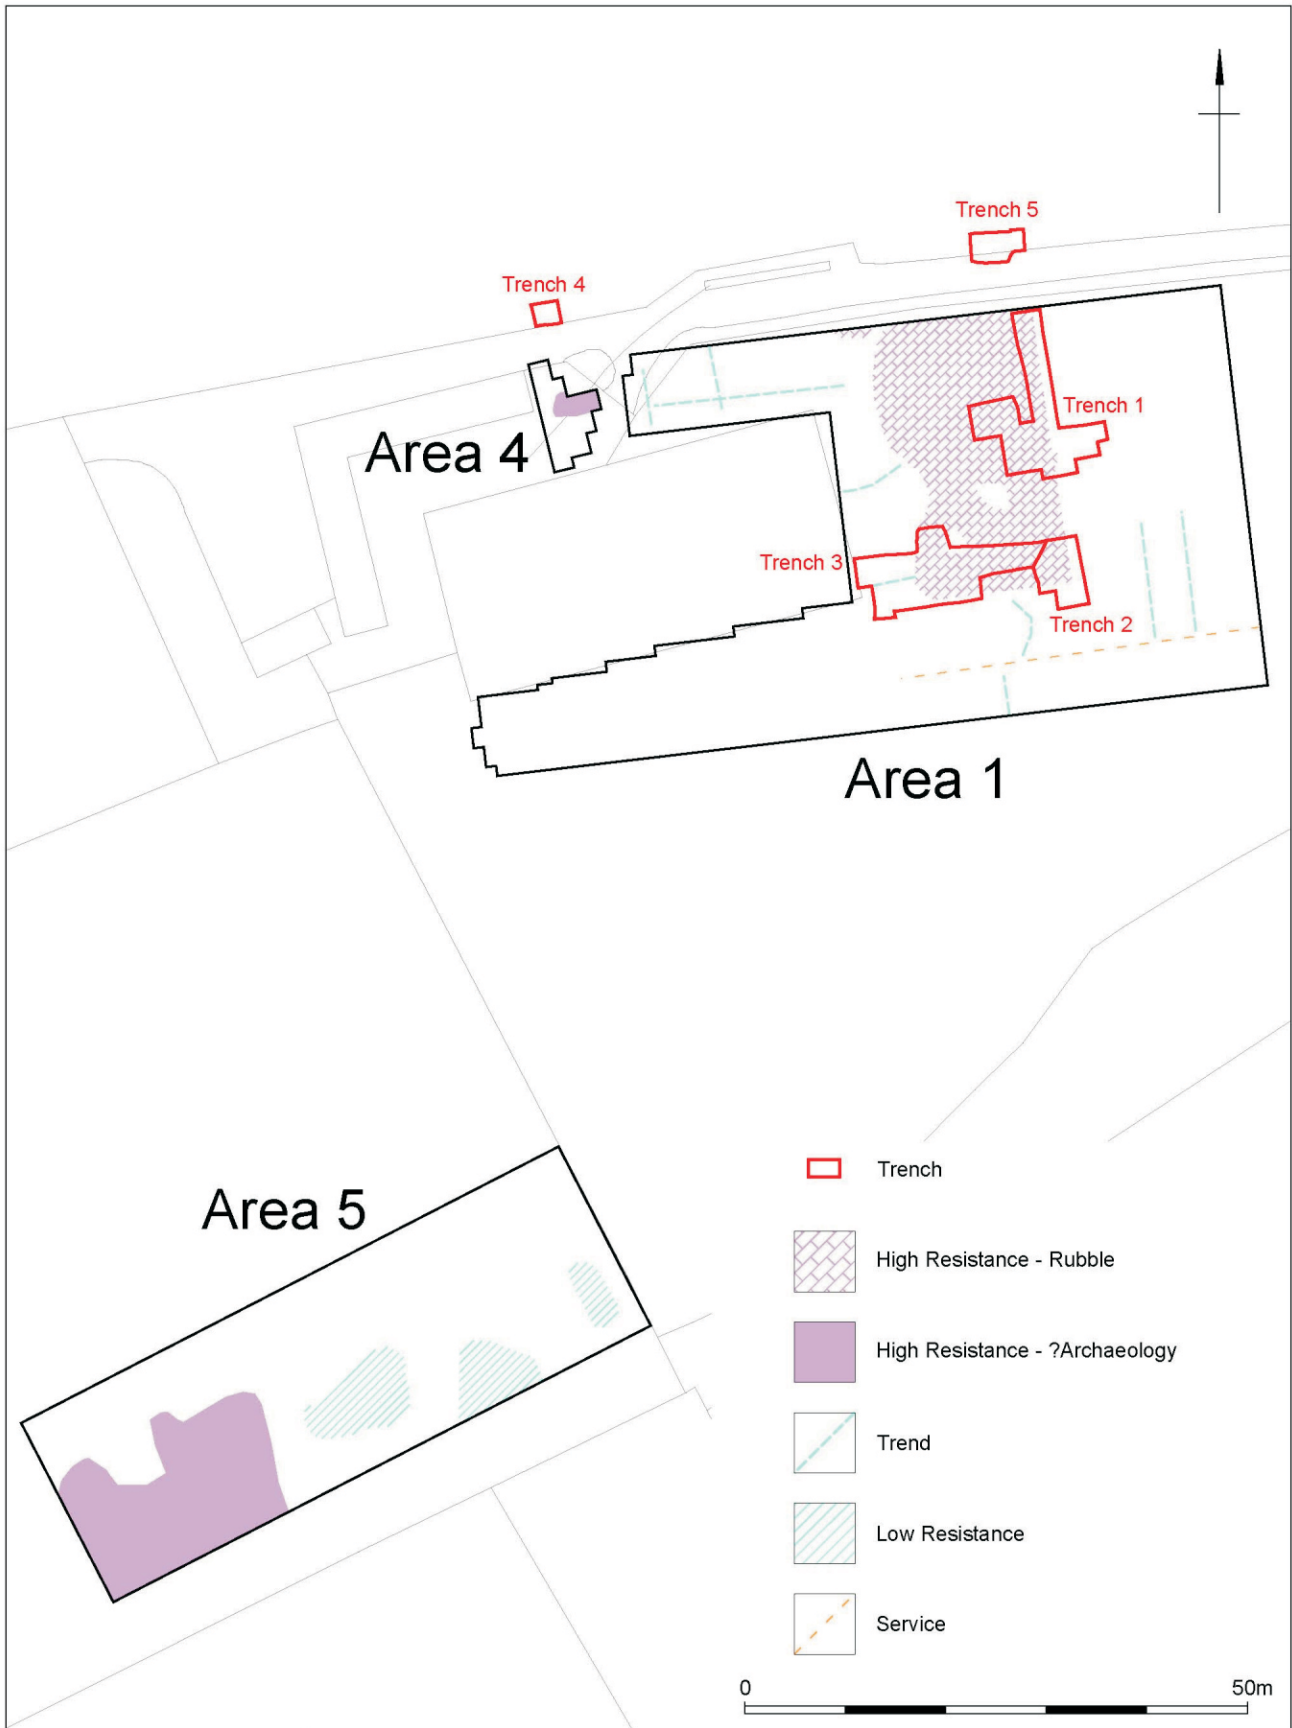
Figure 5

Location of geophysical survey areas

- 4.2.1 Geophysical discussion is derived from the report prepared by GSB Prospection Ltd (2007). Five areas were surveyed using a combination of techniques (**Figure 5**).

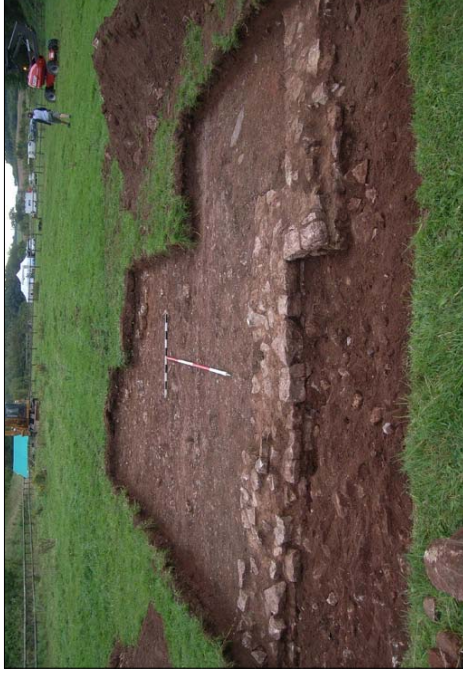
Plate 3: Mid-excavation view of Trench 1 from the west

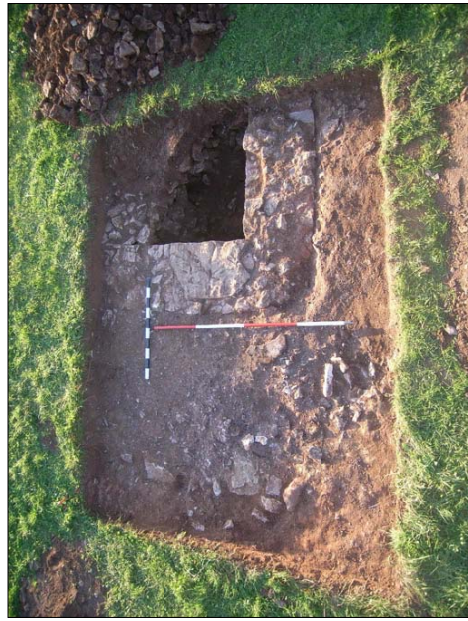
Plate 6: Mid-excavation view of Trench 2, from the east

- 4.4.9 Trench 2 was positioned over geophysical results which suggested the south-eastern corner of the building.
- 4.4.10 Stripping revealed a north – south stone built wall (202) with a western return. To the north-west of this wall and contained within it was a stone rubble demolition deposit (205) similar to (104) and (110). A machine excavated sondage showed this context and wall (202) to be over 2.80m deep (**Figure 10, Plate 7**). From the rubble a number of stone mouldings were retrieved. These included an ovolo moulded jamb and an architrave, both probably dating to the 17th century, although a hollow chamfered jamb is possibly later medieval or early Tudor in date (J. Foyle pers. comm.). At the base of the sondage a drain (209) was found (**Plate 7**) and an environmental sample taken from this context contained coal and fired coal waste, mollusc shells characteristic of shaded conditions, probably coming from the drain itself or associated building rubble, and several fish remains.

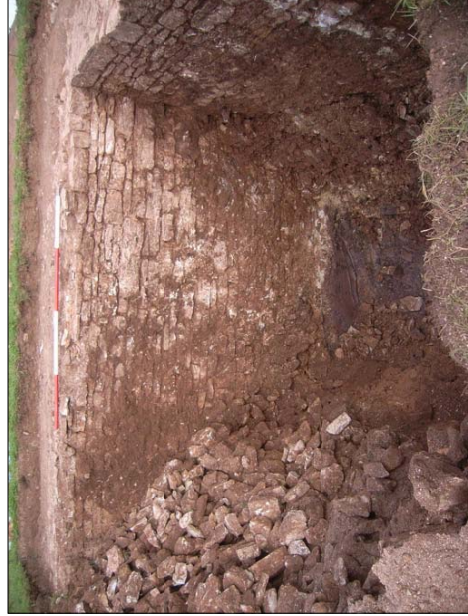
Plate 7: Western elevation of wall (202)

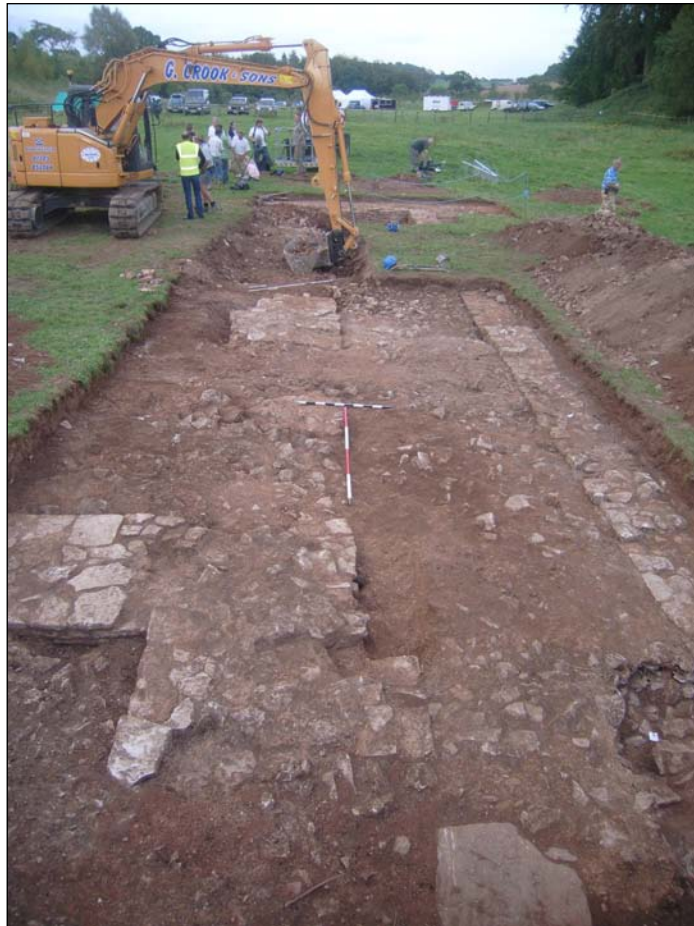
Plate 8: Pre-excavation view of Trench 3, from the west

- 4.4.12 Trench 3 was originally a 2m² area targeted on an exposed outcrop of possible masonry. Exposure of this revealed it to be rubble rather than *in situ* remains and the trench was extended to the north and east, eventually joining with Trench 2.
- 4.4.13 Stripping revealed an east - west aligned wall (312) on the same alignment as wall (202) (**Figure 11, Plate 8**). Of identical construction to (202), it was butted to the north by wall (314) which seemed to form the northern return, although not seen in a sondage further to the north. This suggests a possible dogleg to form a bay, similar to that seen in Trench 1. In common with Trenches 1 and 2 a loose rubble deposit (309) was found contained within the wall, which appeared to be identical to the original rubble deposit encountered (305), and also identical to (310) and (315) which were

- 4.4.14 In addition, a number of areas of masonry ((313), (320), (321) and (324/5)) to the north suggested another wall on a parallel alignment (**Figure 11, Plates 8 & 9**). This was similar in characteristics to (111) in being wider and more substantial than (312). It was deliberately interrupted in at least four places along the length exposed, possibly five. A deep machine excavated sondage along wall (324) and (325) suggests that these breaks may be window bays, as a stone window or door sill (326) was found tied into position approximately 1.6m below the level of stripping (**Figure 12**). Wall (328) formed a northern return of wall (313); in its western elevation a beam slot was visible (**Figure 13, Plate 11**). Although its position would suggest that this is an internal wall, it is of substantial construction and may therefore be the external wall of one of the wings seen in the historic mapping
